## **TECHNICAL REPORT 2**

### **Englishman River Water Service**

#### **Phase 2 - Water Treatment Pilot Testing and Aquifer Storage and Recovery Feasibility Analysis**

**May 2014**

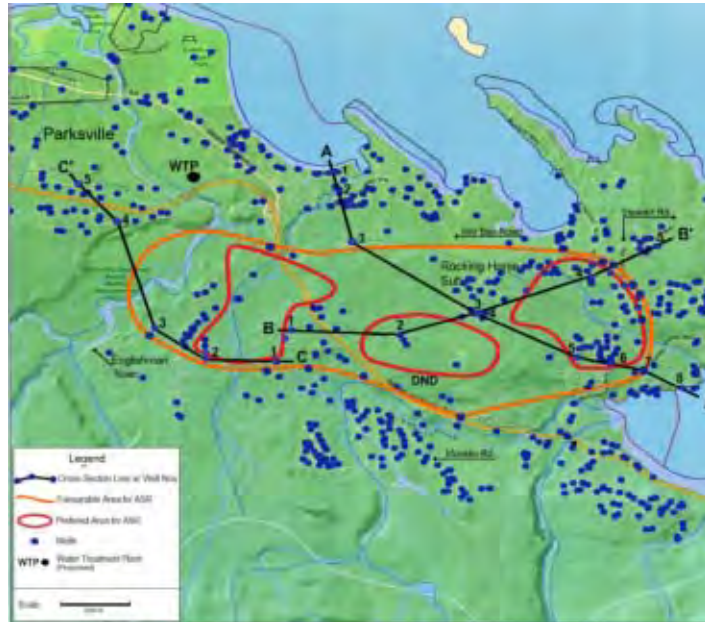
**Figure 2 – Recommended ASR Locations**

An important focus of Phase 2 was a greater investigation into the feasibility of ASR for the ERWS system, which included a comprehensive aquifer study and field testing of an ASR pilot well. In Phase 1, three particular areas of the Nanoose Creek Aquifer were identified as the most suitable for ASR development, as shown in Figure 2. In Phase 2, a pilot ASR well was proposed to be developed in the western-most area, closest to the proposed water treatment plant site. Part of this aquifer's desirability was that it was accessed by relatively few wells. The drawback of this is that the area of the aquifer was not already comprehensively mapped out. Mapping of the aquifer was conducted using existing well records, newly drilled test wells, air and satellite photos, and site investigations. Based on this information it was determined that the target aquifer sits on a relatively flat section of till and bedrock, meaning water injected into the aquifer would likely not move away. The aquifer is confined from above by a layer of clay and silt, as well as an upper aquifer hydraulically isolated from the target aquifer. The target aquifer is thus protected from surface contamination sources. Of the test wells developed, one well along Kaye Road was identified as the most suitable location for developing a pilot ASR well. This pilot well, ASR-1 was developed and subjected to cycle testing.

However, in Nanoose, wells near Claudet Road were identified as potential candidates for conversion to an ASR well system. If successful, the wells could be used to replace three conventional wells nearby that require treatment for manganese and ammonia removal. A capital cost analysis indicated that developing ASR wells at this location would provide a net saving over treating the native groundwater and would reduce the Englishman River Water Treatment Plant by 25 L/s.

It is recommended that the ERWS proceed with cycle testing an ASR pilot system at the Claudet Road site, and determine other potential sites that are close to existing water system infrastructure for future ASR development prior to further development near Kaye Road. While this work will not impact sizing of Phase 1 construction of the water treatment plant, additional ASR systems will supplement the existing water sources during periods of severe drought, and will delay the need to expand the treatment plant under Phase 2.

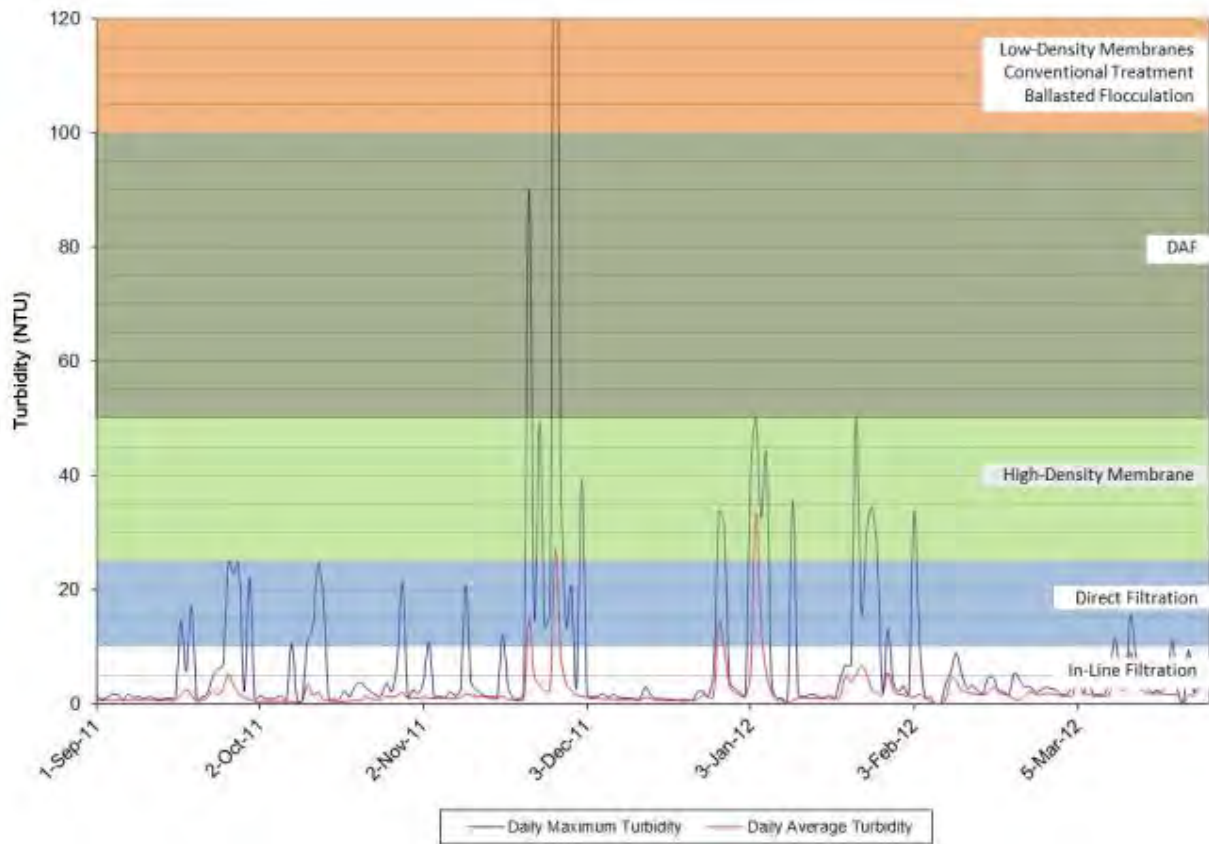
Figure 3-1 - Englishman River Turbidity, 2011/2012

2- Percent annual exceedances of maximum turbidity tolerances, based on the turbidity data collected during the monitoring program.

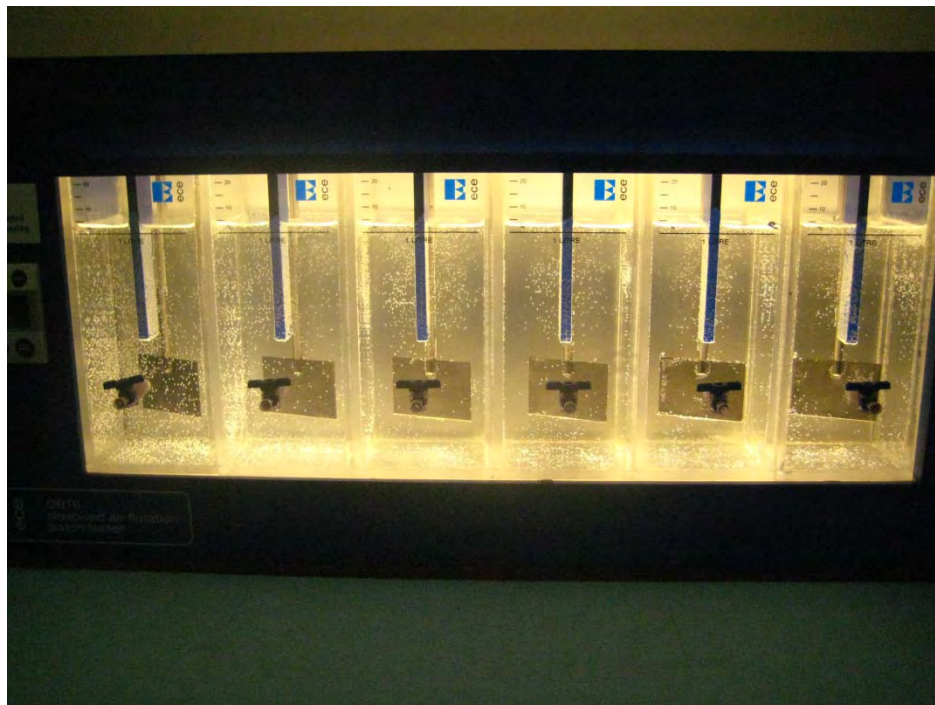
Figure 3-2 - DAF Bench-Scale Apparatus

Bench-scale simulations of the DAF system (Figure 3-2) were conducted using a range of aluminum chlorohydrate coagulant doses. All of the simulations failed to produce a floating floc to remove. Therefore, DAF was deemed not a suitable treatment option for the Englishman River.

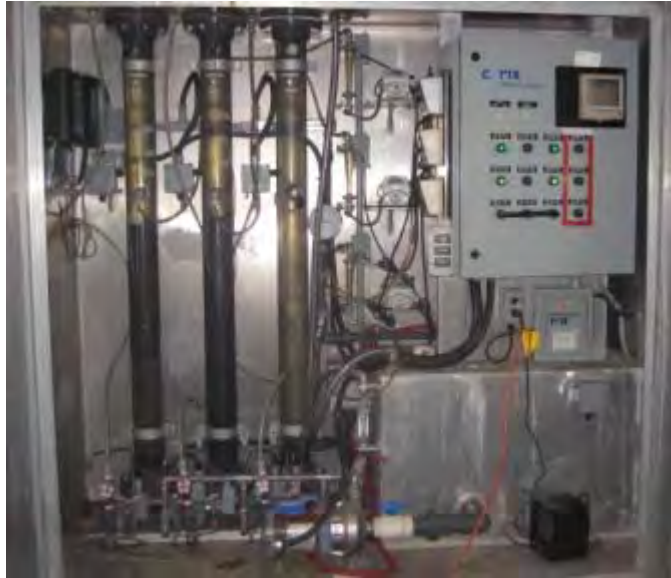
Figure 3-4 - Conventional Treatment Pilot – Filter Columns

The dual-media and mono-media filters performed similarly to each other, achieving similar levels of turbidity removal and having similar length filter runs. The filters were found to perform poorly. The unit filter run volumes (UFRV) were low, meaning that a relatively small volume of water could be treated by the filters before the media would require to be taken offline for backwashing. UFRV values for the pilot ranged from 125 m<sup>3</sup>/m<sup>2</sup> to 174 m<sup>3</sup>/m<sup>2</sup>, below the minimum desired UFRV of 200 m<sup>3</sup>/m<sup>2</sup>. Filter backwashing had to be done frequently to prevent rapid filter breakthrough.

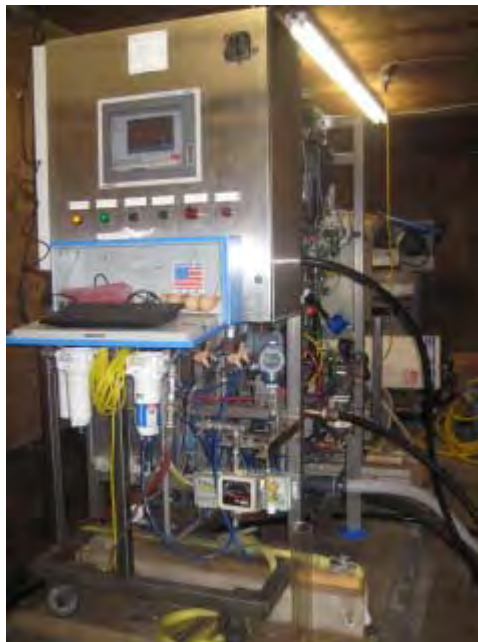
**Figure 3-5 - Membrane Pilot**

A pressurized membrane system was used to pilot membrane performance for the Englishman River. The pilot consisted of pre-filtration using bag filters to remove large particles, followed by coagulation using ACH and membrane filtration. Figure 3-5 shows a photo of the membrane filtration pilot.

The results of Cycle 1 demonstrated that the membranes could consistently reduce turbidity to potable water objectives. During Cycle 1 Englishman River turbidity varied from less than 1 NTU to 100 NTU, and in Cycle 2 turbidity varied from less than 1 NTU to 66 NTU. While turbidity events would often cause the membrane to perform a 30-minute auto-cleaning (Enhanced Flux Maintenance) more frequently, filtered water turbidity continued to meet potable water objectives: Filtered permeate water from Cycle 1 and 2 had a turbidity of 0.01 NTU or less in 99% of all measured samples.

The greatest vulnerability of the membrane pilot was the pre-filtration step. The bag filters would typically become clogged and need replacement during the turbidity events. In the full scale system, this can be addressed by implementing self-cleaning screens as part of membrane pre-filtration.

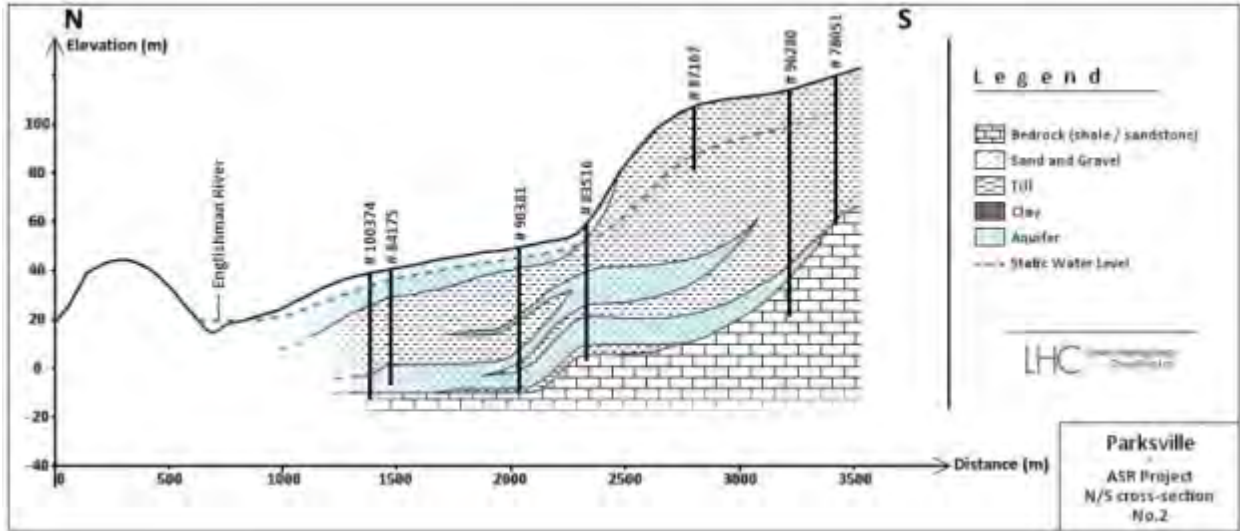
**Figure 4-4 - Example Cross-section of the Nanoose Creek Aquifer**

Above it is a confining layer of clay and silt, on top of which is an upper aquifer, hydraulically isolated from the lower aquifer.

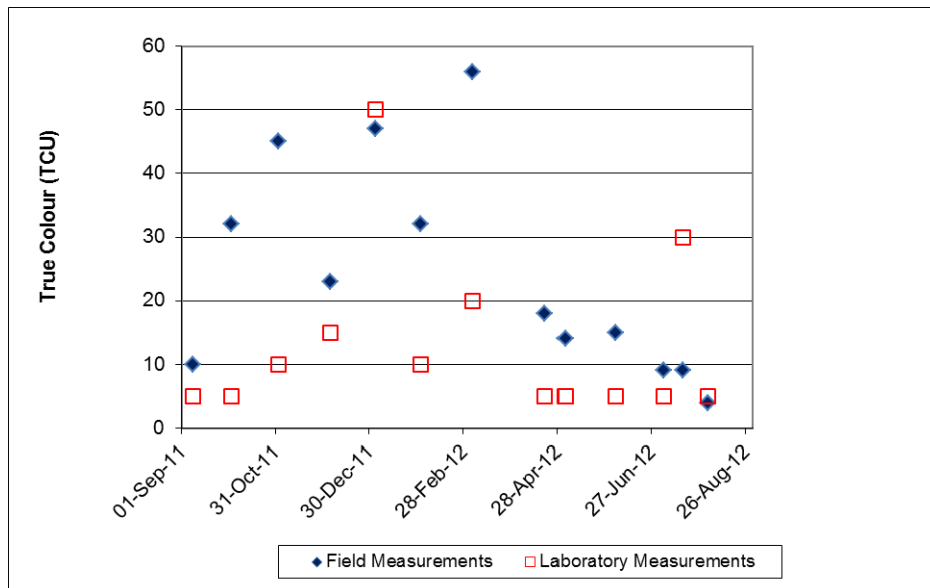
**Figure 2-1 - Comparison of True Colour Data**

True colour as measured in the field and in the laboratory did not agree. Figure 2-1 demonstrates that the field measurements were generally greater than the laboratory measurements, in the order of 10 to 30 TCU. No correlation was readily apparent, and it is uncertain whether the measurements are not as accurate in the field, whether the field measurements and the samples for the laboratory were taken at different times of the day, or whether changes to the chemical composition of the water changed for the collected samples while in transit to the laboratory. The field measurements indicate that true colour regularly exceeded the AO of 15 TCU, while the laboratory data suggests that colour was often below the AO but exceeded this limit during the winter and periodically throughout the rest of the year.

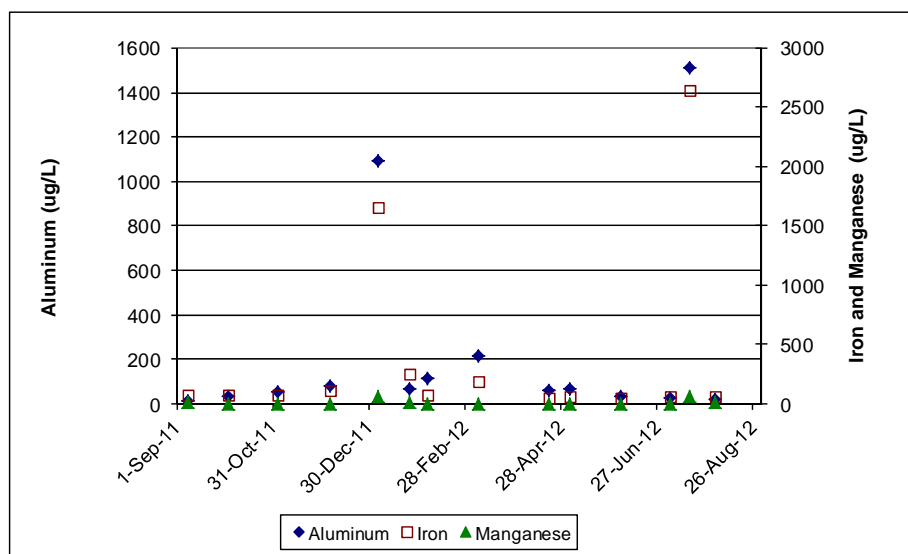
Figure 2-2 - Aluminum, Iron and Manganese Concentrations

The spikes in aluminum, iron and manganese are shown in Figure 2-2. The first spike was observed in January, and the second in July. The possible causes of these peaks in metal concentrations are discussed in Sections 3.4 and 3.5. Iron and manganese have AO levels set on their impact on the visual appeal of water. High concentrations of iron can cause a red/yellow discolouration of the water, staining laundry and plumbing fixtures. Similarly, high concentrations of manganese can cause a dark discolouration of the water. The GCDWQ states that aluminum concentrations should not increase by more than 0.100 mg/L during treatment, but does not set a limit for aluminum in raw water. However, the spike in aluminum concentrations was highlighted in this document because of the increase was so large in both of the spike events. Beyond these two events iron, manganese and aluminum were measured at levels acceptable for drinking water.

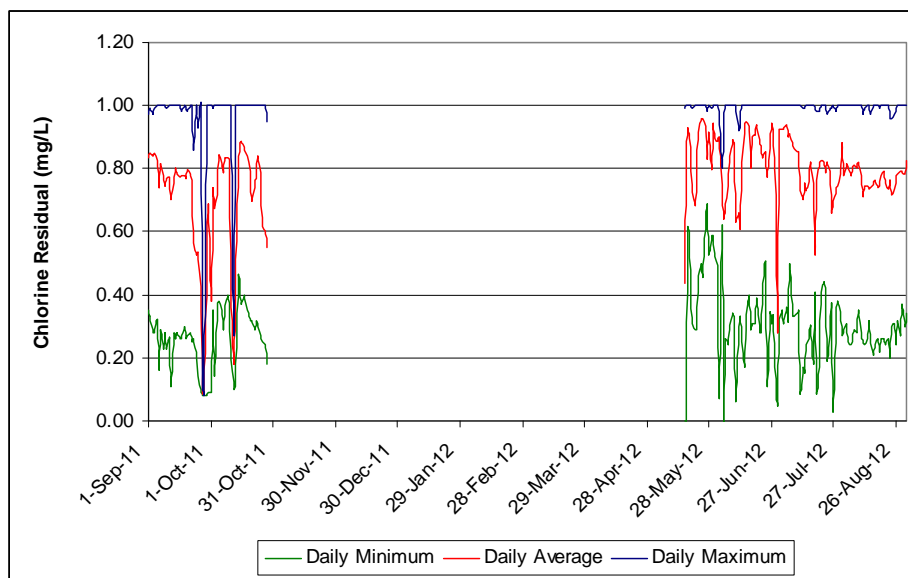
**Figure 2-5 - Free Chlorine Residual**

The chlorine residual was measured in 15 minute increments, at the location where the intake connects to the distribution system, and is shown in Figure 2-5. As a constant chlorine dose was applied to the water, significant changes to the residual act as an indicator that the water has undergone some form of change. It is part of typical operations that the City of Parksville brings the existing intake offline during the winter when turbidity in the Englishman River exceeds 1 NTU and relies solely on the well supply. In 2011 the intake was brought offline on October 29 and brought back online May 16, 2012. Therefore, the chlorine residual in the distribution system was not examined during this timeframe.

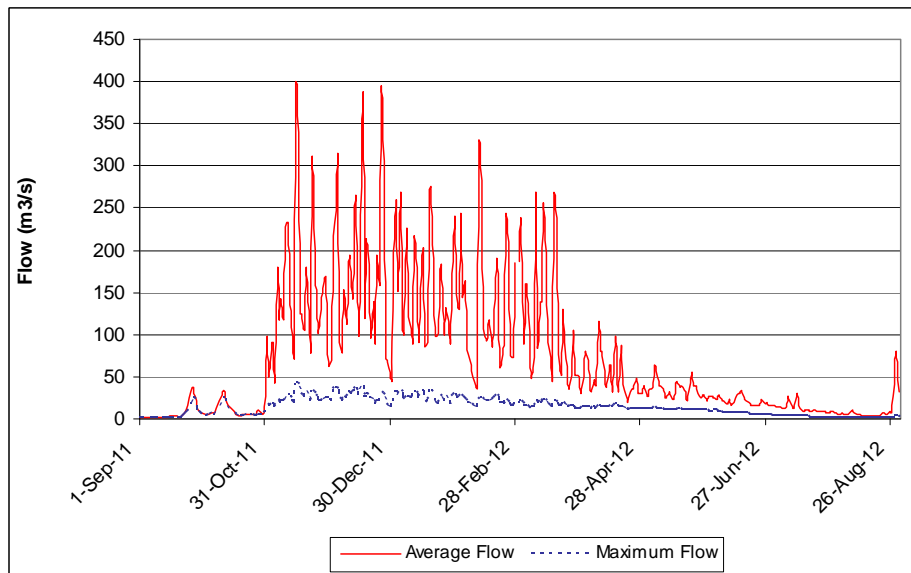
**Figure 3-1 - River Flow Rates**

Figures 3-1 and 3-2 show daily Englishman River flow rates and precipitation. During the fall months of September and October river flow rates are relatively low, averaging 7 m<sup>3</sup>/s. In early November, river flow rates increased dramatically to the order of 24 m<sup>3</sup>/s and remained at these levels until March, where the spring flow rates decreased to an average river flow rate of 14 m<sup>3</sup>/s. In June, flow rates further decreased to less than 4 m<sup>3</sup>/s for the summer. This seasonal change correlates with the overall seasonal changes in precipitation. Rainfall intensity and frequency were at their greatest from the months of November to January. From April to June the daily amount of rainfall fell but the frequency increased, reflecting a relatively wet spring. Rainfall intensity and frequency fell to its lowest levels throughout July and August.

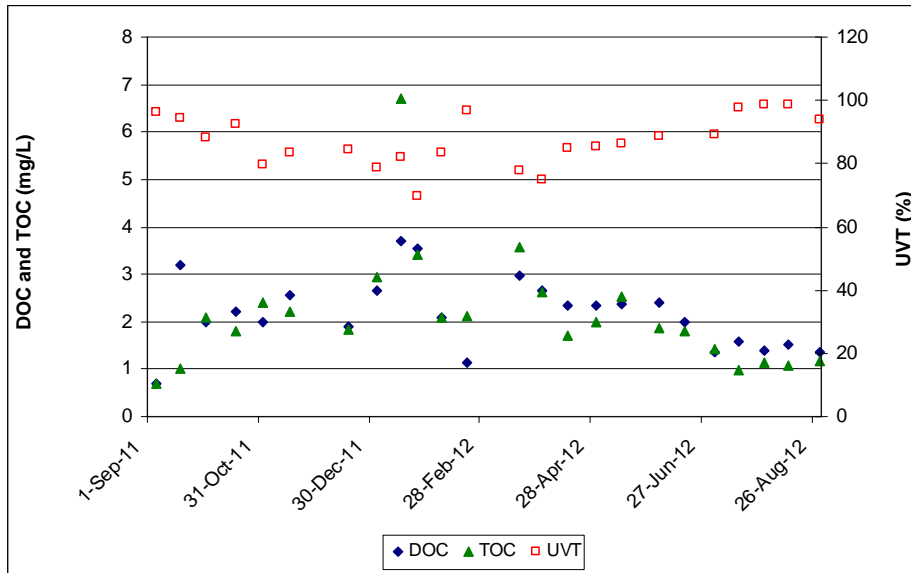
Figure 3-4 - Organic Concentrations and UVT

Figure 3-4 shows the measured values of total organic carbon (TOC), dissolved organic carbon (DOC) and UV Transmittance (UVT). The data shows that the three parameters oscillate over time, although there a slight increase in TOC and DOC was observed in the winter. The apparent increase in DOC was accompanied by a decrease in UVT in the spring, suggesting an inverse correlation between UVT and DOC. This relationship is commonly observed in surface water sources. However, plotting UVT directly against DOC, as shown in Figure 3-5, shows a poor correlation, even when the larger TOC value of 6.7 mg/L is omitted from the data set. A calculation of R<sup>2</sup>-values for this plot, which indicates on a scale of 0 to 1 how close the data points fall along a best-fit line, produced values of 0.2 to 0.6, which are well below the desired value of 0.9 or greater that would indicate a significant correlation. Qualitatively, it appears that a decrease measured on a UVT analyzer would indicate that an increase in DOC had occurred, but in the absence of a numerical correlation an accurate projection of organic concentrations based on UVT cannot be calculated.

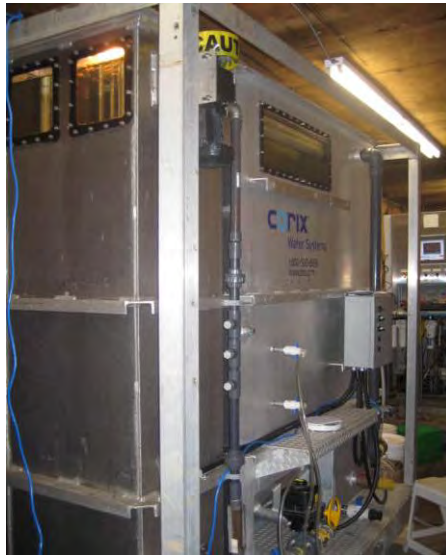
**Figure 2-2  
Flocculation/Sedimentation Unit**

The conventional treatment system was supplied by Corix. Raw water was pumped directly from the Englishman River by the City of Parksville to a raw water tank. The water was subsequently pumped to the two-stage flocculation basins equipped with variable speed mixers. Chemicals were dosed inline prior to the static inline mixer upstream of the floc tanks. Flocculated water then entered the sedimentation tank (Figure 2-2) where settling tubes assist in further removing the floc from the clarified water, which was collected on top of the sedimentation tank through a perforated pipe and discharged into the adjacent clarifier.

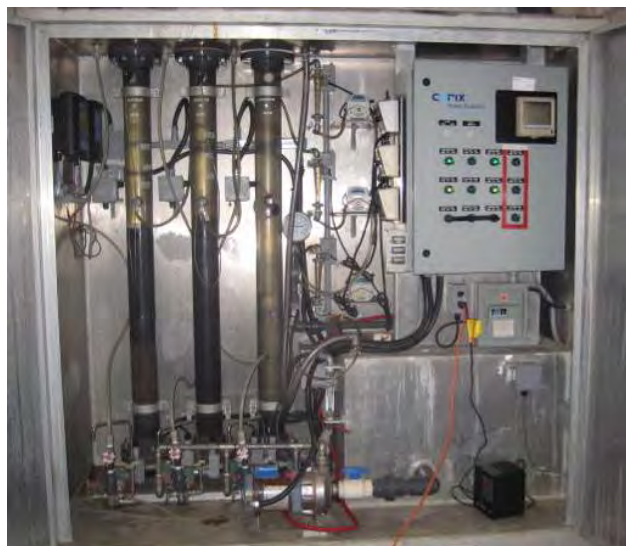
**Figure 2-3  
Pilot Gravity Filters**

A portion of the clarified water was diverted to two 100 mm gravity filters columns for further removal of particulate matter. The pilot filters were capable of receiving flows from 0.2 L/min up to 2 L/min. Figure 2-3 shows the conventional pilot filter unit. Media configurations are described in Table 2-2.

**Table 2-2  
Gravity Filter Media Configurations**

Filter	Media	Depth (mm)	Effective Size (mm)	Uniformity Coefficient
1	Anthracite	500	1.0-1.1	1.4
	Sand	350	0.45-0.55	≤ 1.5
2	Anthracite	860	1.0-1.1	1.4
