**ENGLISHMAN RIVER INTAKE  
AND TREATMENT FACILITIES**

**SITE #1**

**Environmental Assessment of  
Alternative Water Intake Sites in Englishman River**

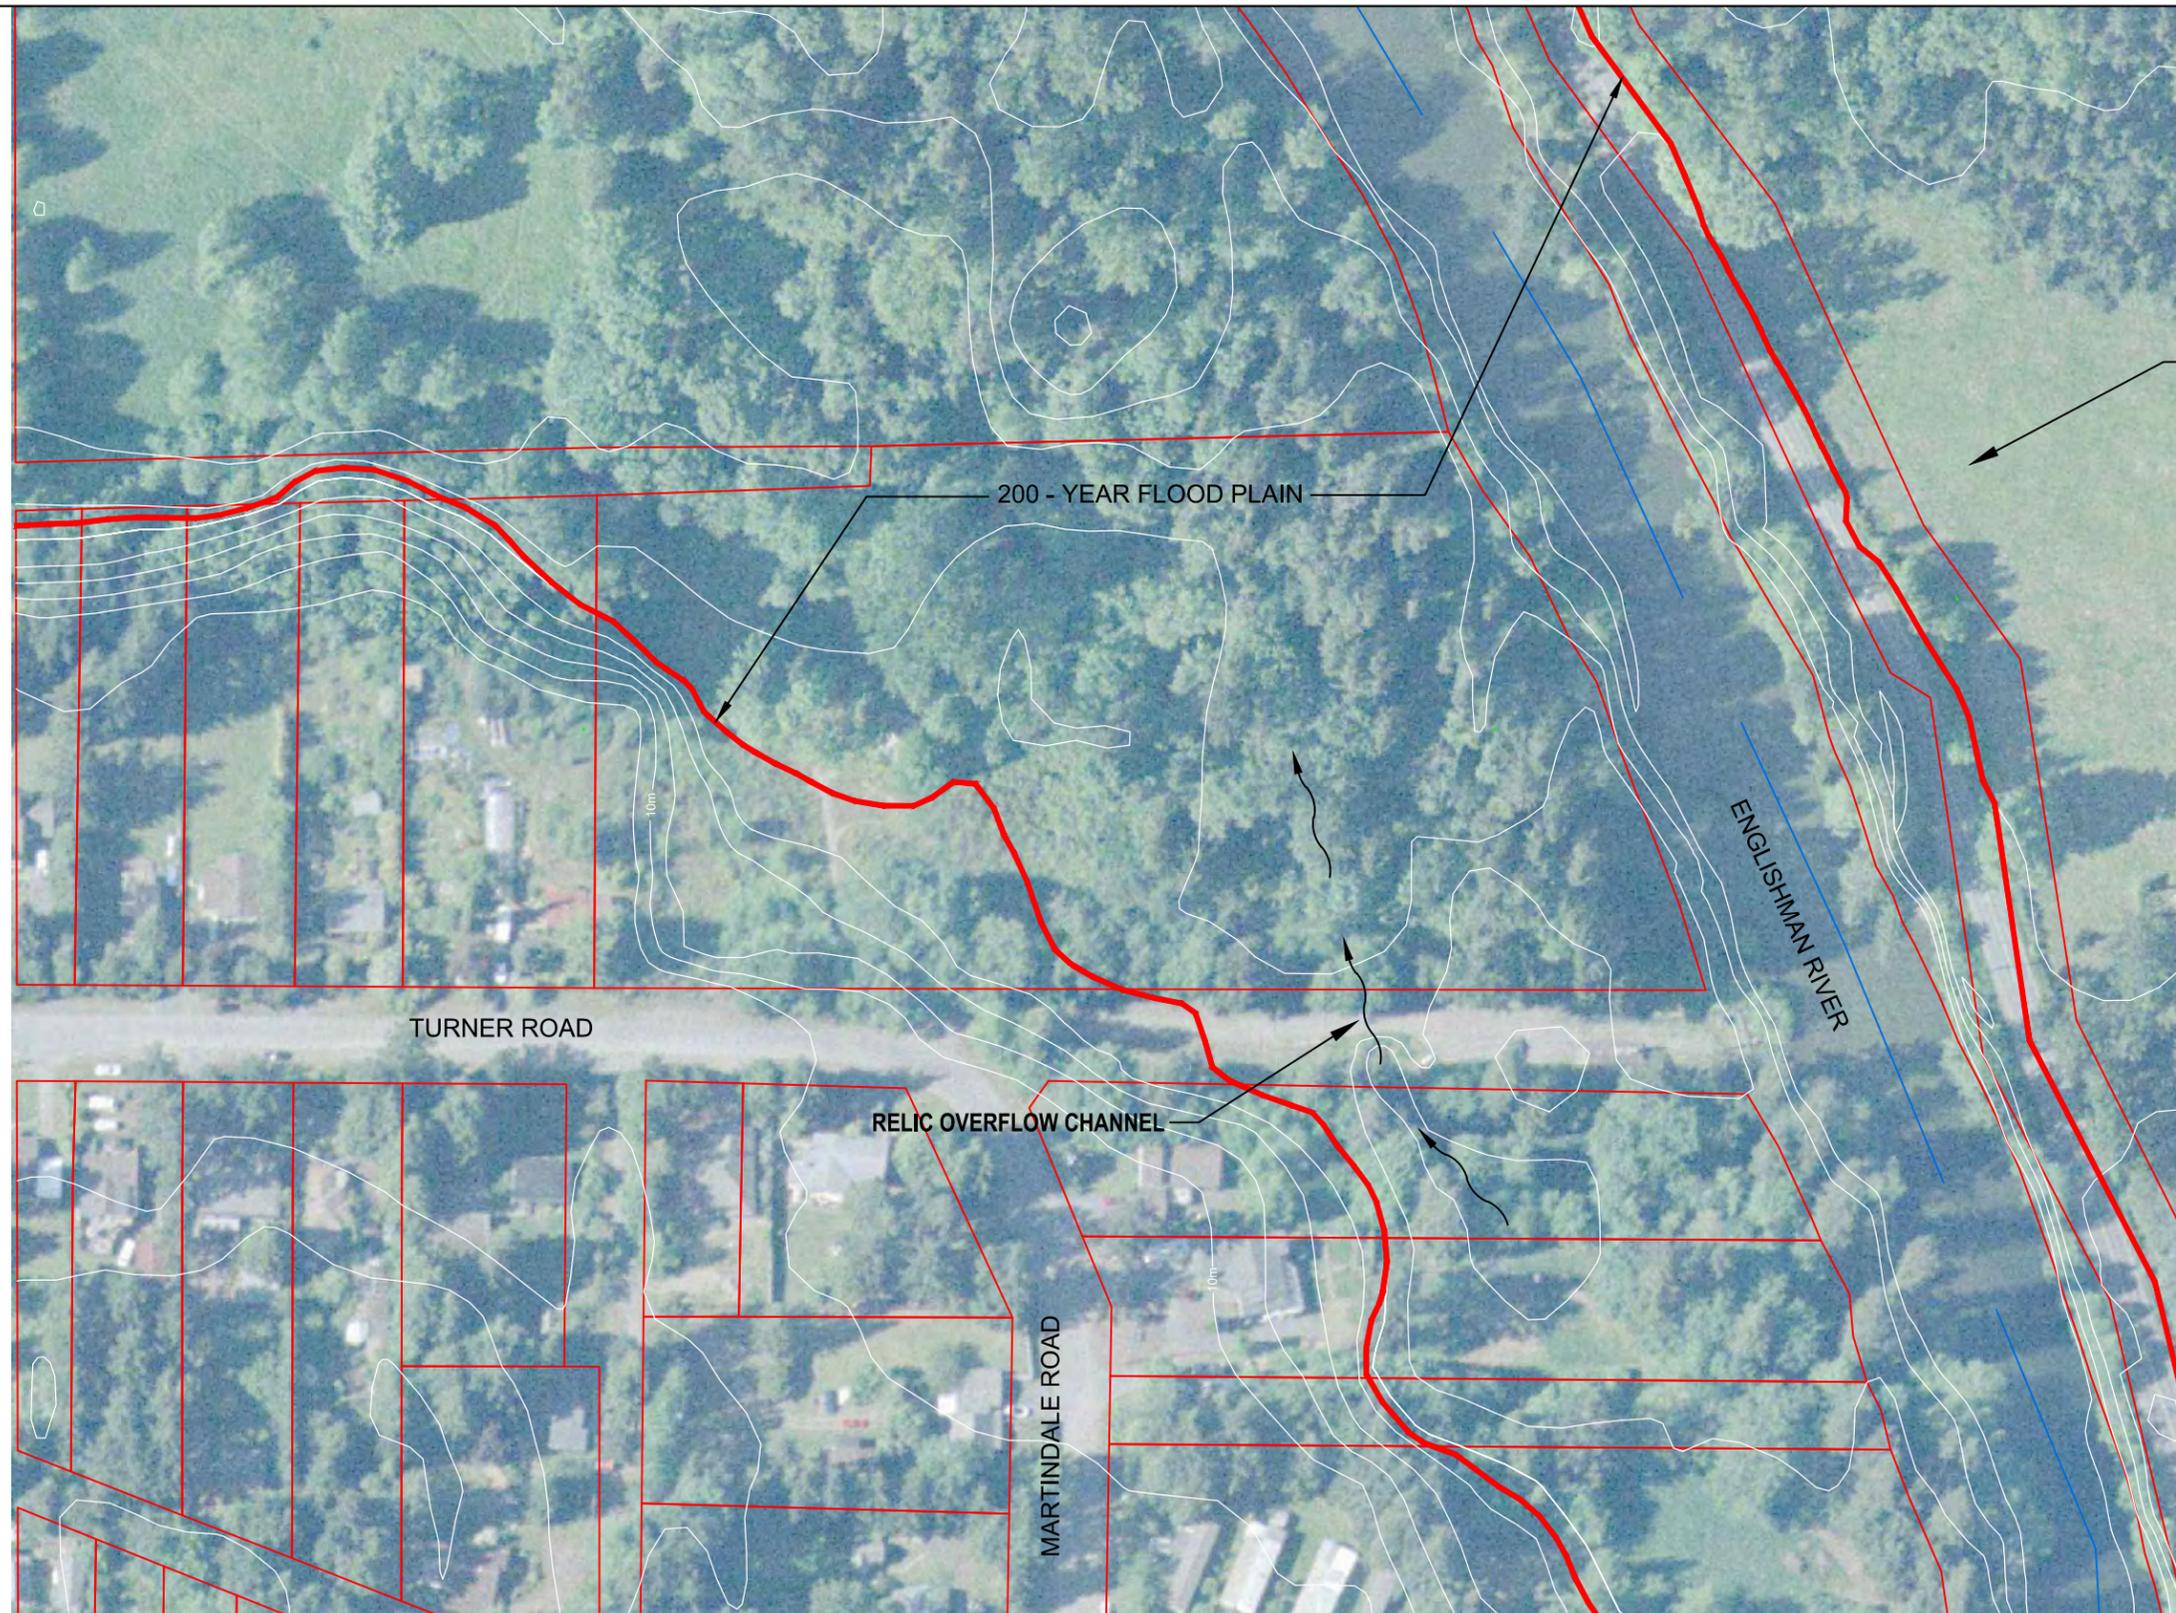
Figure 3

RIGHT BANK FLOODPLAIN IS  
LARGELY RESTRICTED BY THE  
ROAD ELEVATIONS OPPOSITE SITE  
#5

200 - YEAR FLOOD PLAIN

RELIC OVERFLOW CHANNEL

**SITE #5**

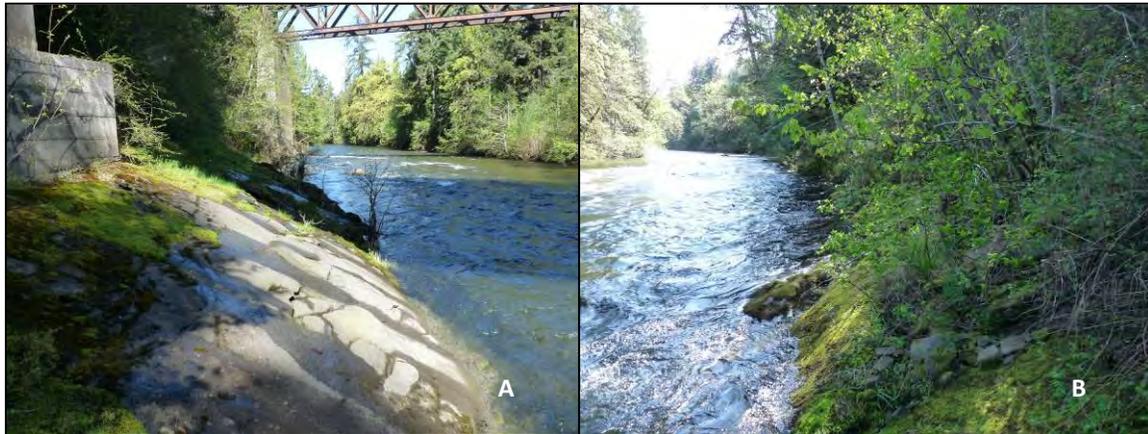
Figure 2. Two photographs of the vegetation along the northern bank of the Englishman River near the proposed intake site. Looking downstream from the highway bridge (A) and looking upstream from the highway bridge (B) (and includes the area near the proposed intake site).

The proposed plan calls for the installation of the intake site along the northern bank of the Englishman River on the upstream side of the highway bridge, with the associated pipe running east for ~180 m along the north bank before crossing the river within the currently-existing railway right-of-way. This would necessitate some disturbance to the existing vegetation communities along the north bank of the river, including the potential removal of several mature trees near the proposed intake site. Much of the vegetation along this corridor, however, has already been significantly disturbed by the construction of either the highway bridge or the railway bridge, and most of the vegetation consists of shrubby re-growth with little tree regeneration (Figure 2). It is expected that any disturbance associated with the installation of the intake site and associated pipeline would have little or no disturbance to the vegetation of the site that would be more significant than the levels of disturbance that have already occurred due to highway and railway bridge construction. As such, the potential impacts to key indicators are expected to be low. No species-at-risk were observed at this location during the field visit. However, because riparian ecosystems tend to support a different, and often more diverse flora and fauna than adjacent upland habitats, there is some potential for species-at-risk to occur in this area. Despite this, the impacts to species-at-risk are expected to be minimal to nil given the level of impact that has occurred at the site in the past.

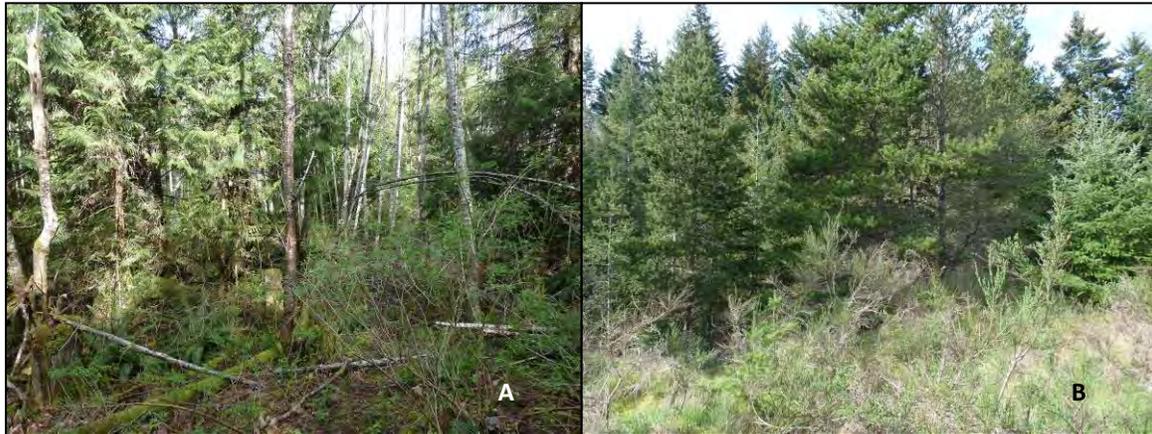
Figure 3. Sensitive habitats documented along the proposed pipeline corridor between the Englishman River and the proposed WTP site: A) Red Alder bottomland; B) Shore Pine grove.

Moderate environmental impacts are anticipated within the upland second-growth coniferous forests where the construction of the pipeline connecting the intake site with the WTP would require the removal of a number of trees (primarily Douglas-fir *Pseudotsuga menziesii*) along a ~250 m stretch of pipe. This area is dominated by mid-seral second-growth Douglas-fir, with a minor component of other tree species such as Bigleaf Maple (*Acer macrophyllum*), Red Alder (*Alnus rubra*), Western Hemlock (*Tsuga heterophylla*), and Western Redcedar (*Thuja plicata*). The understory, which is dominated by Sword Fern (*Polystichum munitum*) and Salal (*Gaultheria shallon*), is relatively sparse and poorly developed in most areas due to the high canopy cover afforded by the Douglas-fir trees. Unusual habitat features that were documented along this proposed corridor during the site visit include an area of low-lying Red Alder bottomland located on the east side of the proposed corridor (nearest UTM: 407360, 5461766) and a small grove of Shore Pine (*Pinus contorta* var. *contorta*) located at the northwestern corner of the disturbed area that is proposed as the site of the WTP (representative UTM: 407518, 5461809) (Figure 3). These habitat types are less widely distributed within the region than second-growth coniferous forest, and thus any disturbances to these habitats have a greater potential to impact species of plants and wildlife that are sporadic or rare. Given the scarcity of such habitats in the area, it is recommended that any construction or development activities avoid disturbance to these habitat features whenever possible.

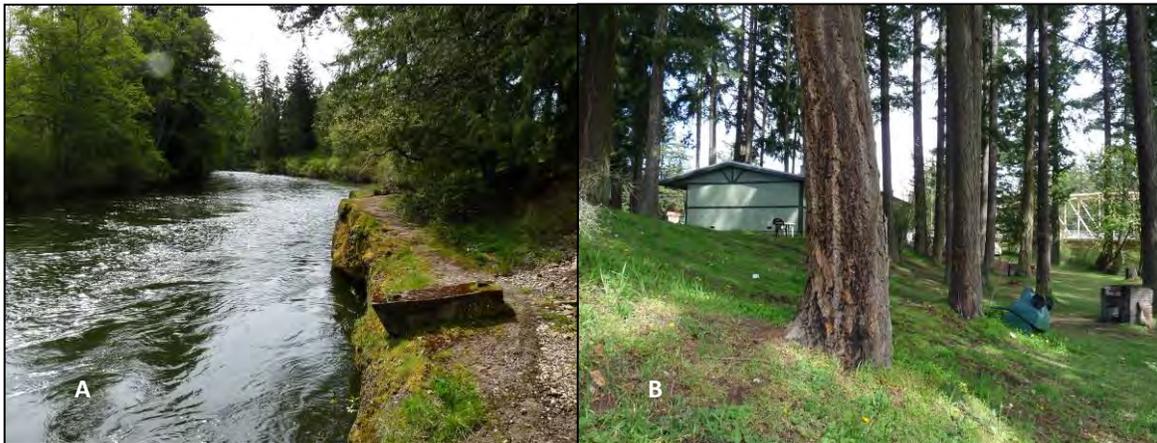
Figure 5. Proposed intake site (A) and the motel area where the WTP would potentially be built (B).

Compared to Site 1, Site 3 is highly disturbed with an existing motel, highly modified Douglas-fir forested habitat, bedrock, and weedy species of plants (Figure 5). The site is also in some proximity to a Shelley Creek wetland (Figure 6) and as such mitigation measures may be needed to ensure that this ecosystem is not affected. Overall, the impacts expected from development at Site 3 are considered minimal to nil.

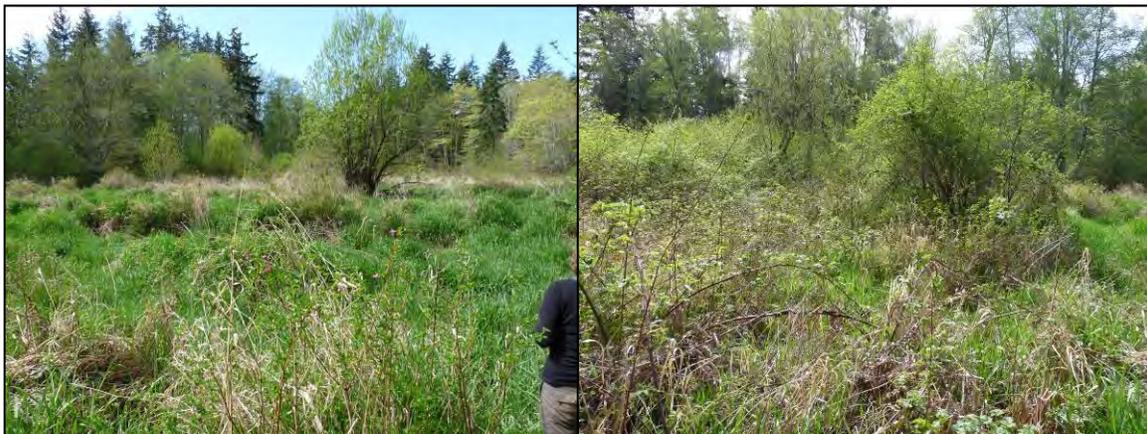
Figure 6. Shelley Creek wetland, located immediately west of the motel (and west of where the WTP would potentially be developed).

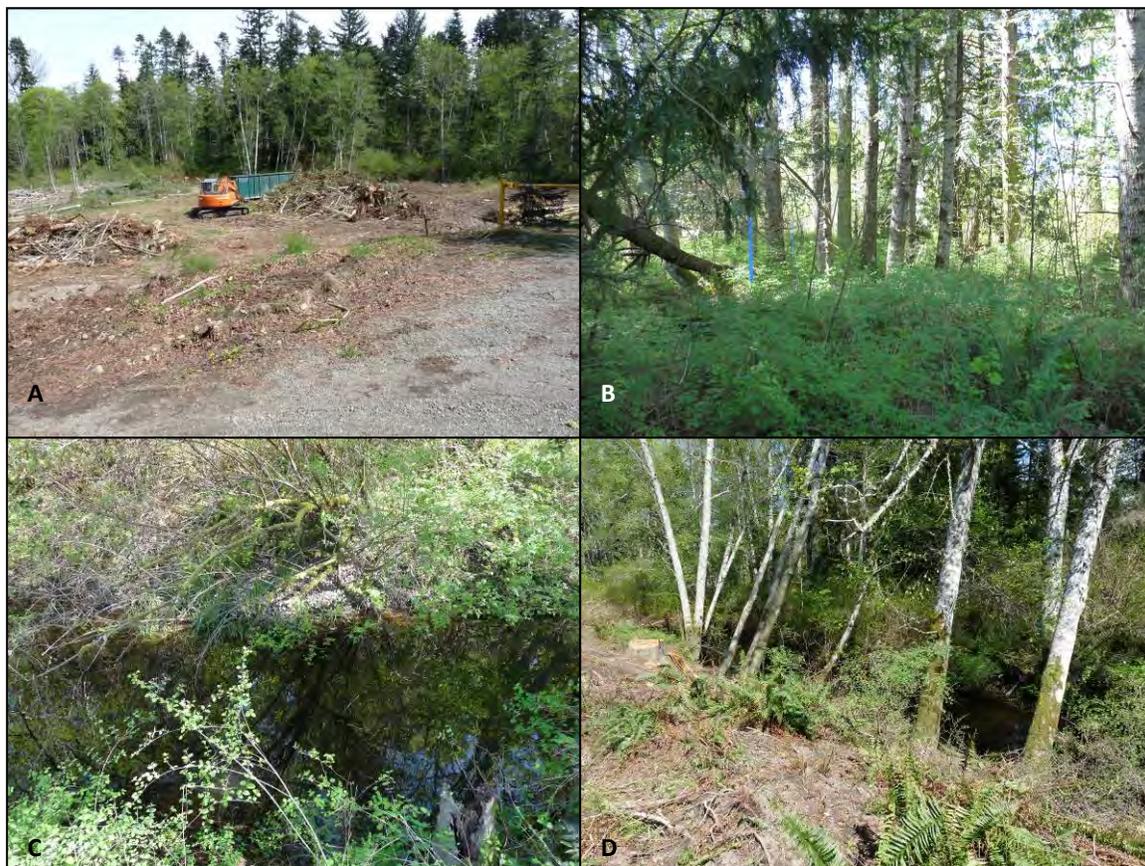
Figure 7. Habitats present at Site 5: A) recently cleared land adjacent to Turner Road; B) alluvial mixed forest along the north bank of the Englishman River; and C) and D) permanently flooded pool bisecting the property, which may be a breeding site for Red-legged Frogs.

Site 5 has been substantially impacted through current clearing activities and is characterized by a large cleared area and a substantial area of riparian mixed forest (Figure 7). Impacts to the cleared area are expected to be negligible; however, there would be impacts to the riparian mixed forest and associated habitats, which could impact species-at-risk or their habitats. The potential impacts to the key indicators are anticipated to be greatest at Site 5, rendering it the least-preferred option of all sites assessed.
